Permaculture Design Course
Gabrielle Anderson

Site Survey Project

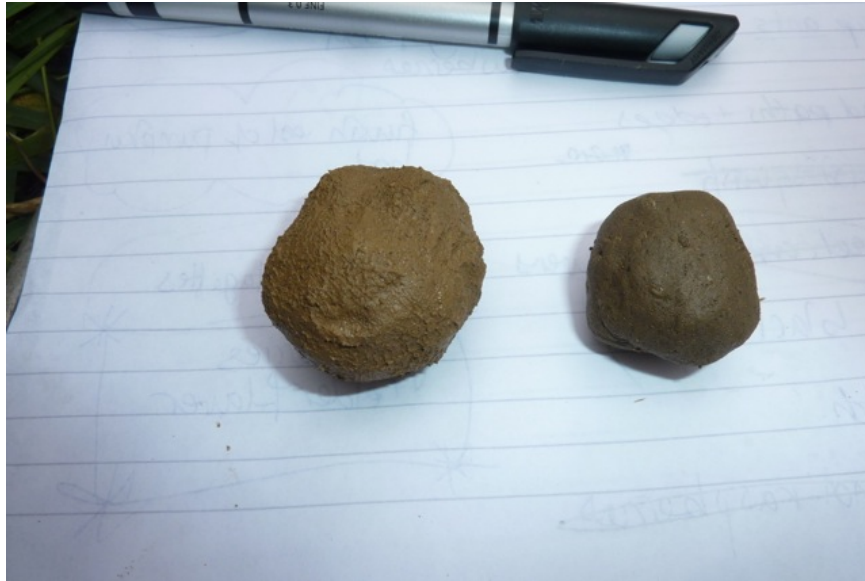
- **Soil** Three soil samples were taken and the sites are marked on the map.
 - **Soil sample one** was a mixed sample of predominately gritty silt loam but with in the sample there were patches of a more clay soil. This area was turned over when large macrocarpa trees were felled and the stumps removed and the area levelled some years ago. Photos show samples taken near surface and then deeper down.

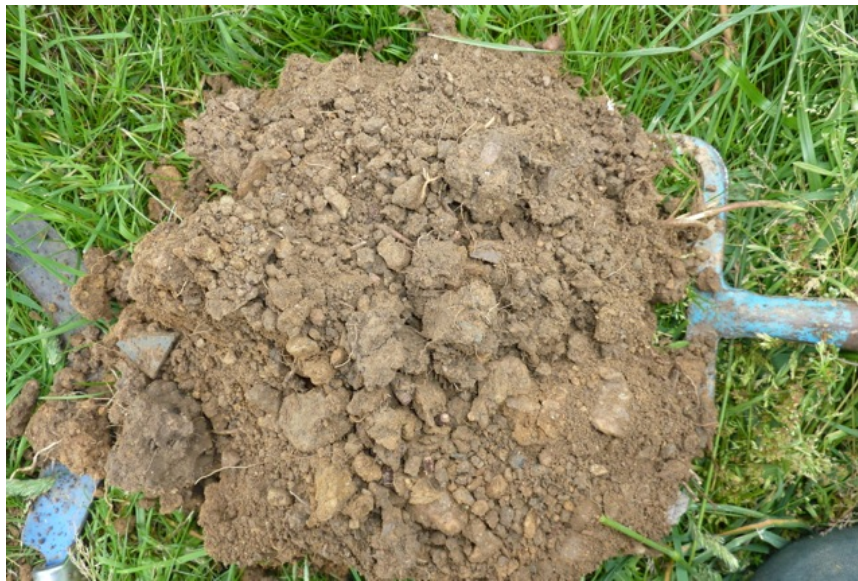
- **Soil sample two** was gritty and loose as it came out of the ground. It too proved to be a sandy silt loam and this area has been dug over on a couple of occasions.

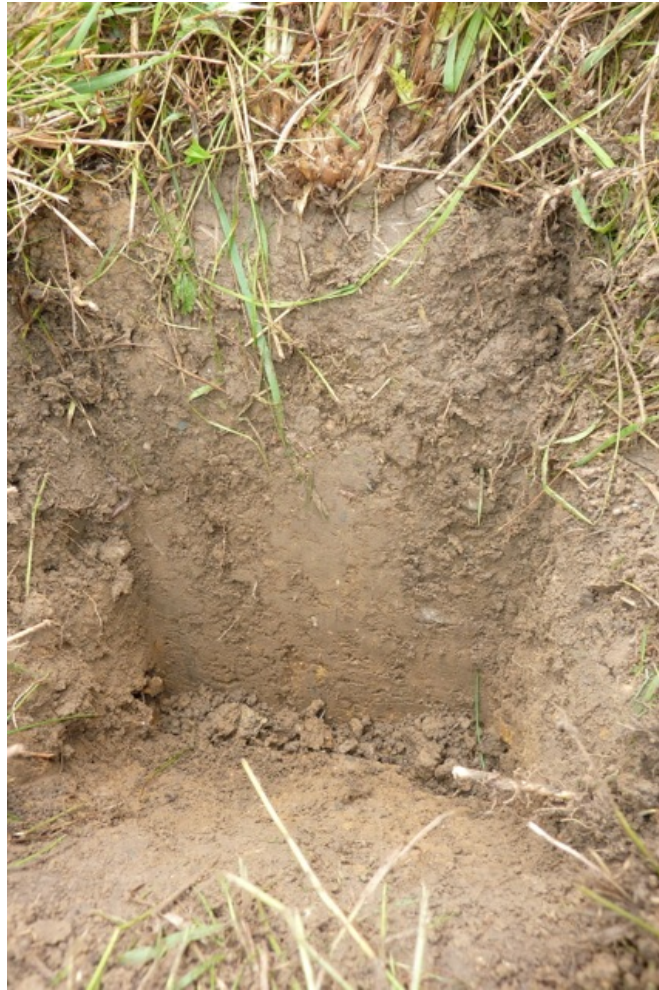
- **Soil sample three** was taken from the edge of the site and the only area not to have been dug over in recent years. It was no surprise that this sample too was a silty loam with plenty of sand and more organic matter at the surface. Deeper down there was a evidence of a bit of clay in the mix as the ball was noticeably stiffer than the subsoil samples at the first two sites. It changes in texture and becomes a little stickier at the deeper level but will not take a polish and is still predominately a sandy silt loam but now with some clay in the mix.

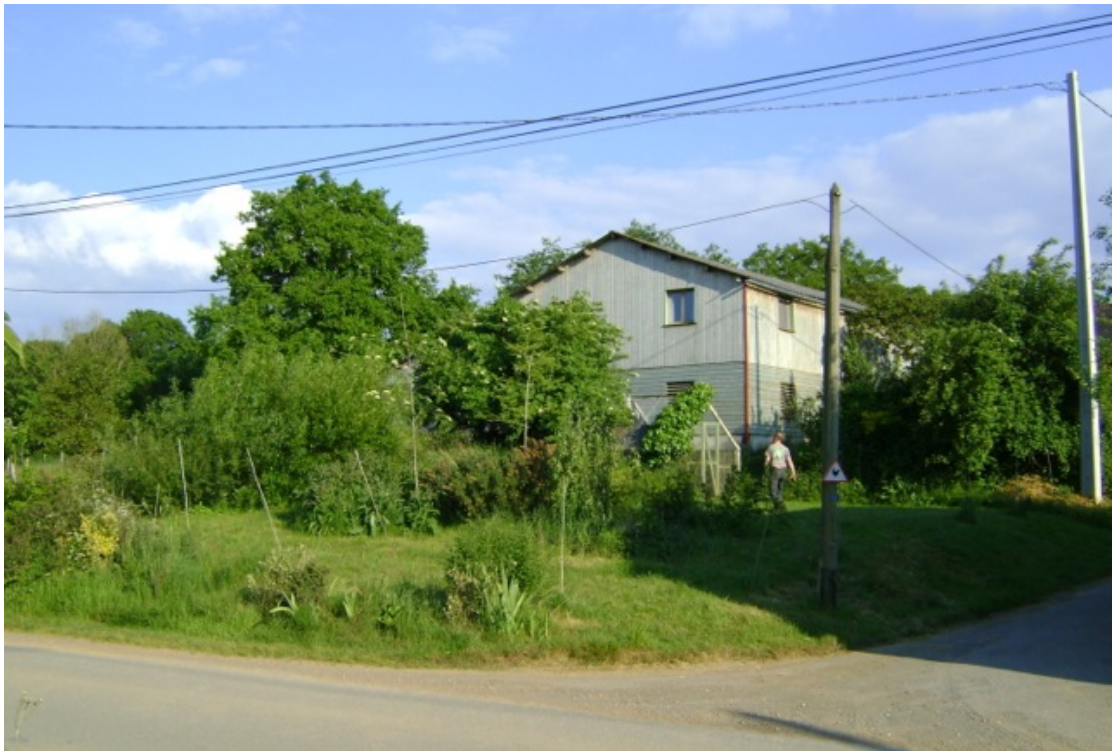
This photograph was taken facing the northwest corner of the site and the position of the camera is marked on the map. In this photo you can see

- the proximity of the area to the rear of our house
- the large bank of shade cast by the building next door in summer afternoons- when the sun is shining that is!
- the power and telephone lines that cross over the site
